SAN ANTONIO CONVENTION CENTER SECTION L1E

L1-CW140

FREEMAN PLANTOUR

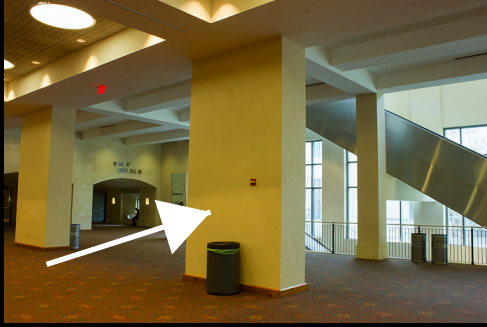
NOTE: VIEW FROM REAR.

NOTE:
HEIGHT MEASUREMENTS
ARE TAKEN FROM TOP
OF BASE TO CEILING.

NOTE:
THIS COLUMN HAS AN
IRREGULAR SHAPE.

COLUMN FOOTPRINT/ DIMENSIONS:

- A= 28"W x 184^{9/16}"H
- B= 5^{3/4}"W x 188^{7/16}"H
- C= 34^{5/16}"W x 197^{5/8}"H
- D= 32^{1/16}"W x 179^{5/16}"H
- E= 96^{3/8}"W x 179^{5/16}"H
- F= 31^{5/8}"W x 179^{3/16}"H
- G= 33^{15/16}"W x 197^{5/16}"H
- H= 6^{3/16}"W x 188^{3/16}"H

SUGGESTIONS:
ONLY INSTALL WALL
GRAPHIC OR MIS
COLUMN WRAP.

EQUIPMENT:
1 SCISSOR LIFT
10' LADDER

MATERIAL:
PHOTOTEX
WALL FROG
MIS UNIT

LABOR:
MEN= 2
TIME= 2HR
